Feasibility Study
Disposal of Dredged Material
Morris Cove, New Haven Harbor

Disposal Area Monitoring System Damos

Contribution 36

A FEASIBILITY STUDY OF THE
DISPOSAL OF DREDGED MATERIAL AT
MORRIS COVE, NEW HAVEN HARBOR

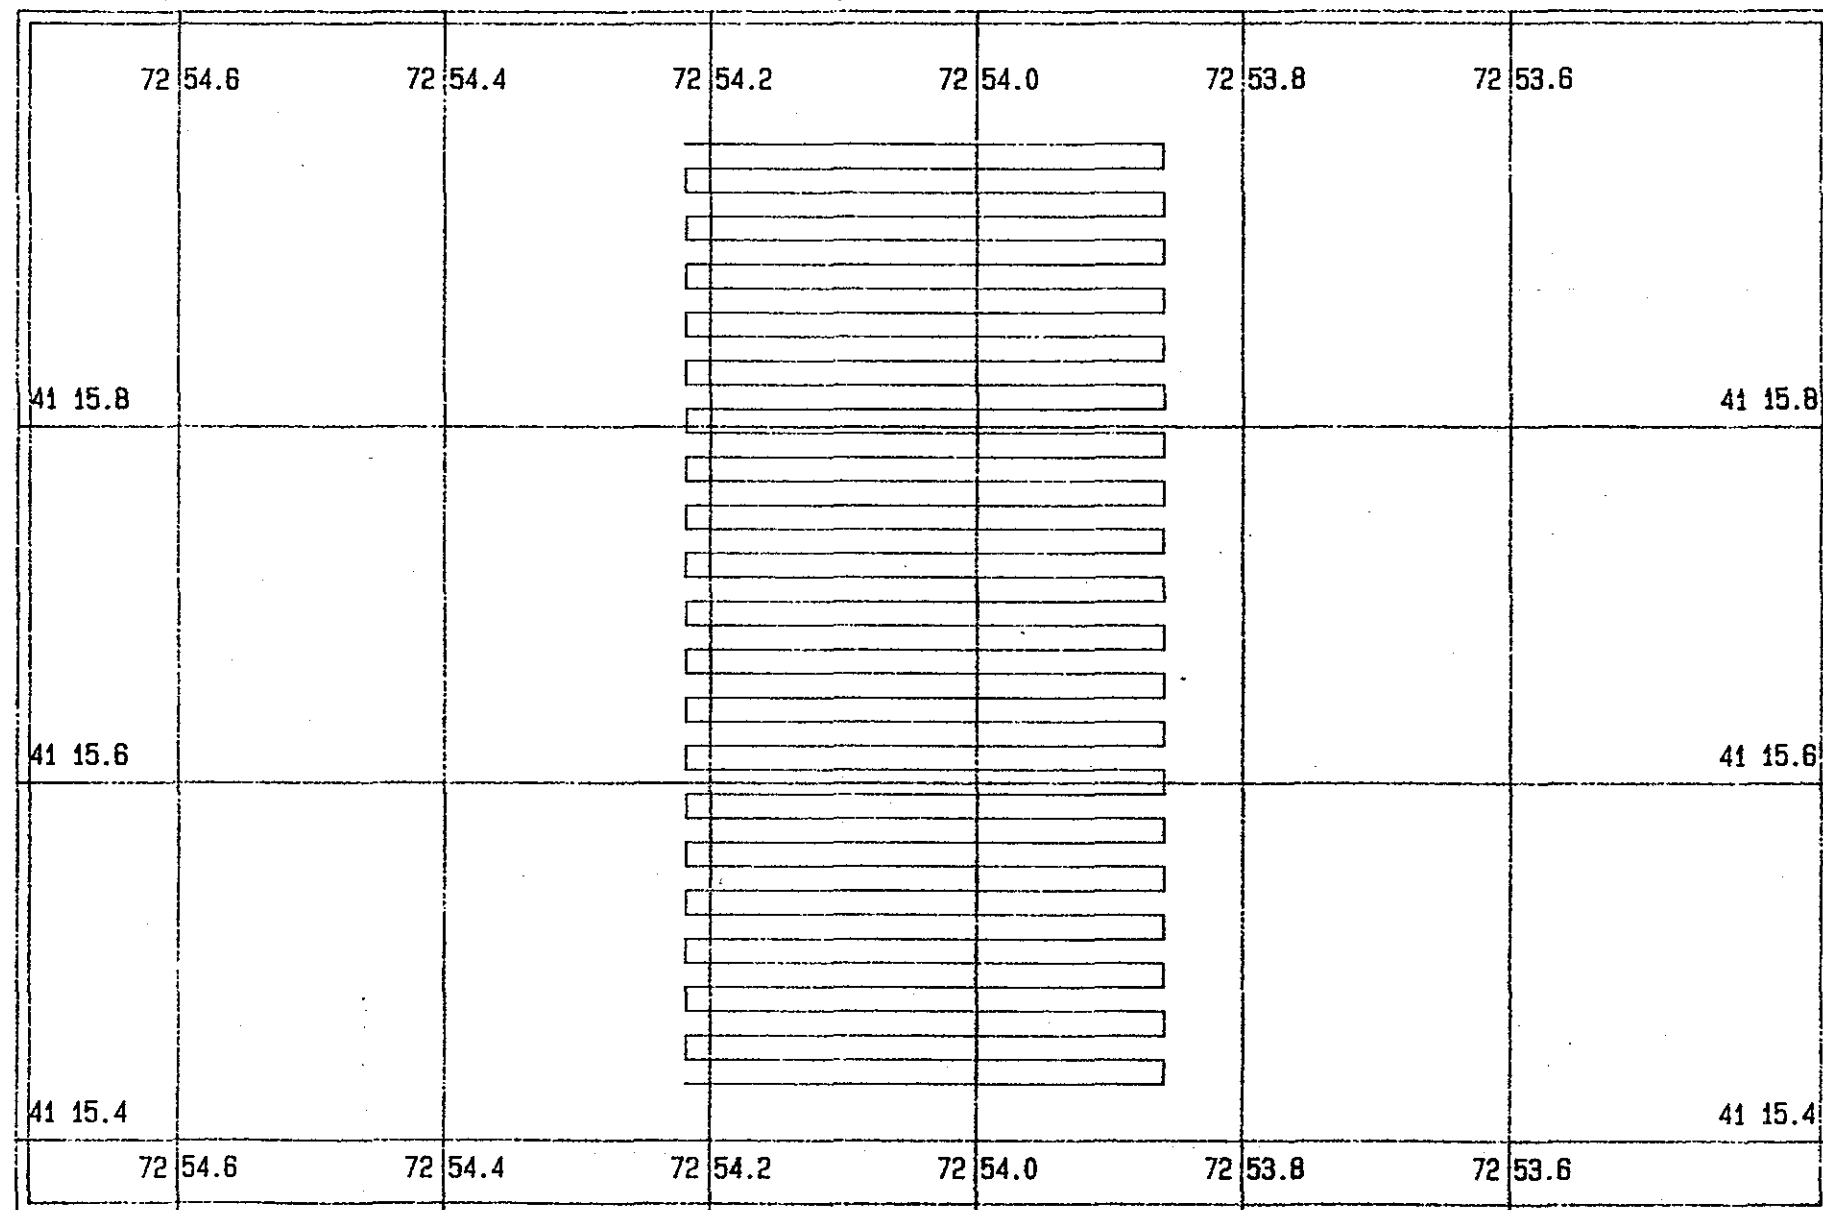
Figure 2.0-1. Bathymetric Survey Lanes

On March 11, 1983 a bathymetric survey of the Morris Cove borrow pit and the surrounding area was performed. This survey was conducted at a 25 meter lane spacing with the 38 lanes running in an east-west orientation as shown in Figure 2.0-1. In order to maintain a high degree of position accuracy, navigation control for this and all other aspects of the cruise was provided by the SAI Navigation and Data Acquisition System. This system utilizes a Del Norte Model 540 microwave positioning system integrated with an Apple II microcomputer to provide a position accuracy of ± 2 meters. Depth data from a Raytheon Model DE719B recording fathometer with a 200 KHz transducer were input into this microcomputer system via a Raytheon Model SSD-100 digitizer. Shore stations for the Del Norte positioning system were located at Lighthouse Point Light at $41^{\circ}14.932N$, $72^{\circ}54.254W$ and at New Haven Harbor Lower Range Light at $41^{\circ}15.640N$, $72^{\circ}56.111W$.

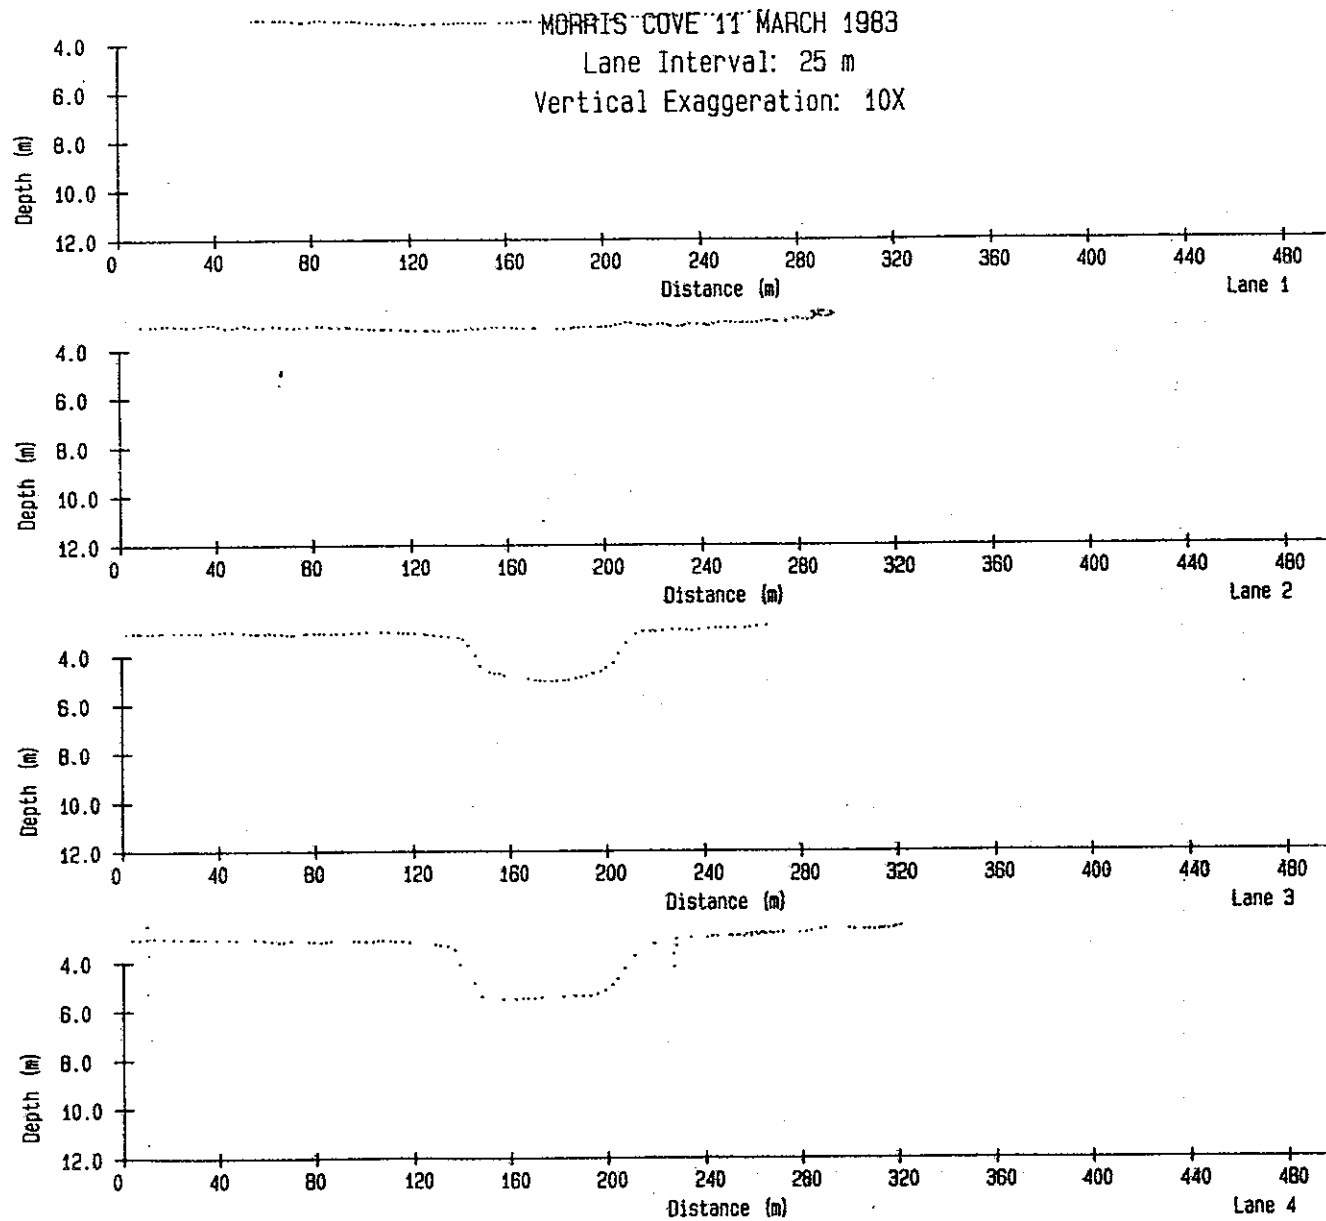
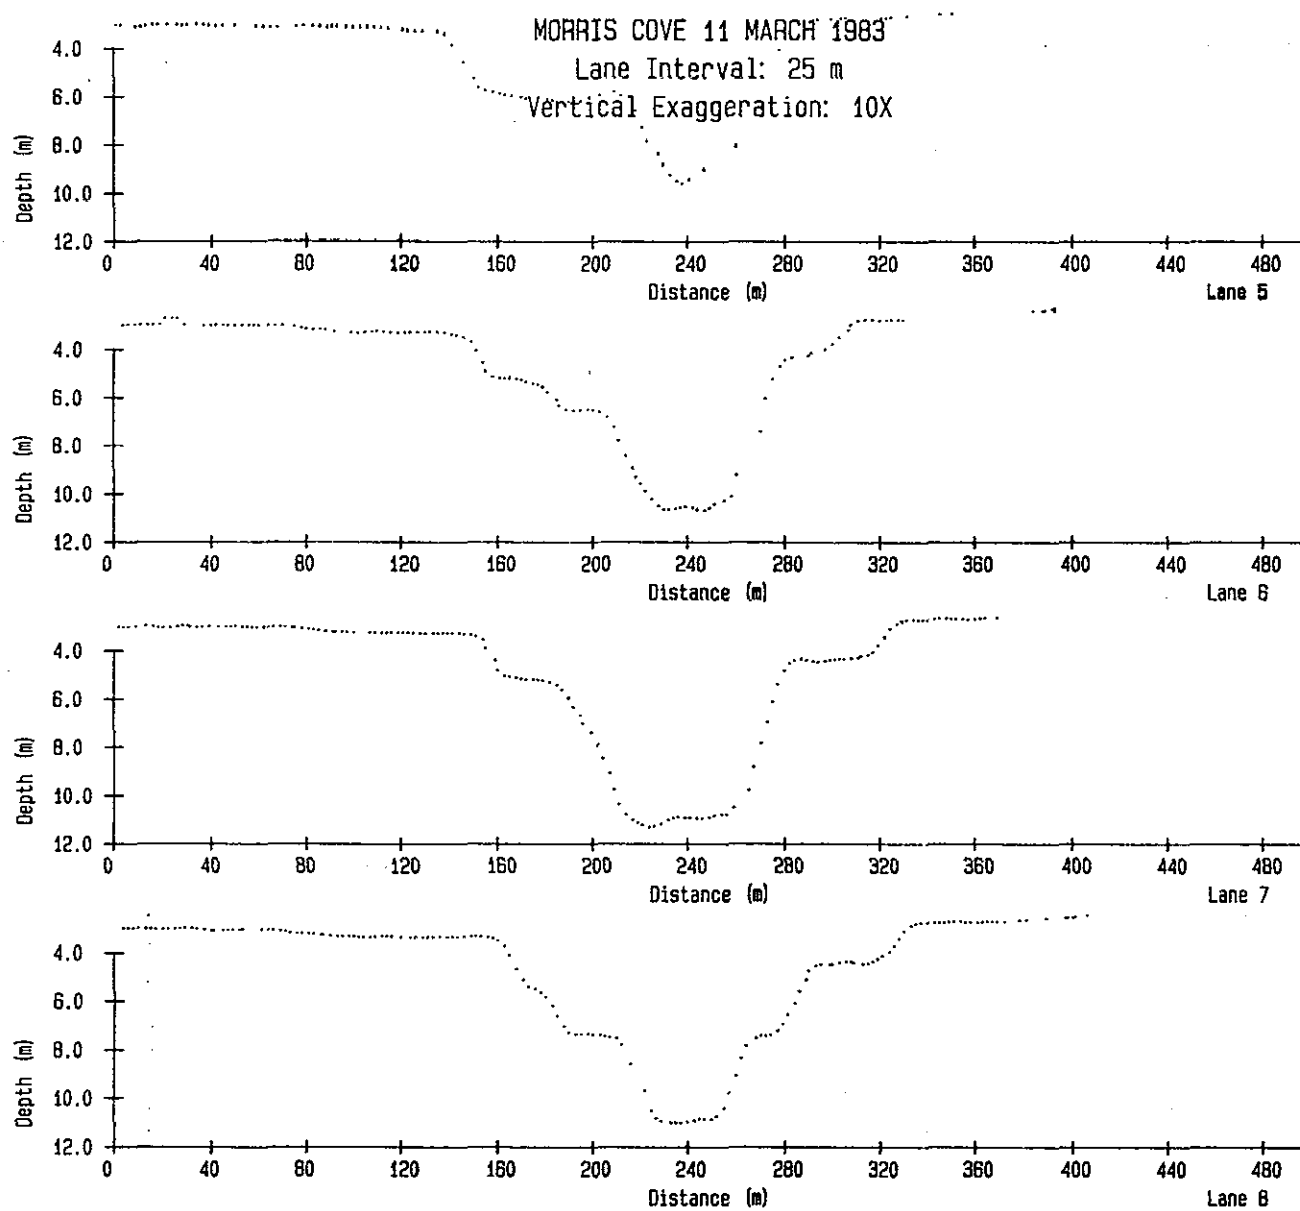
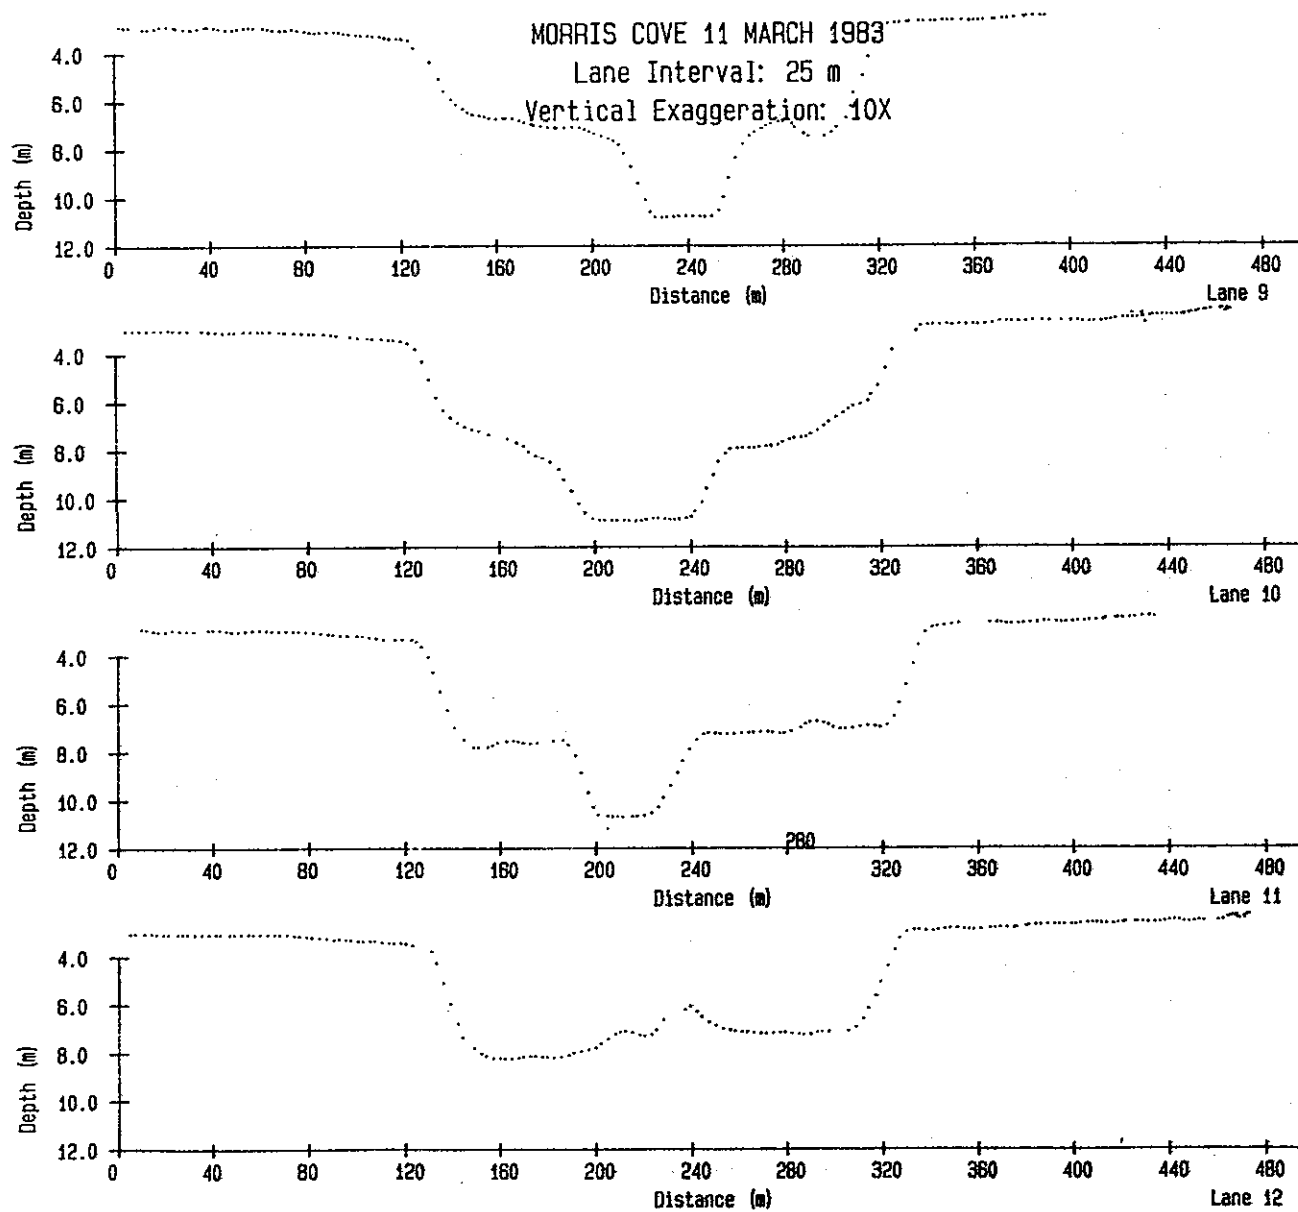
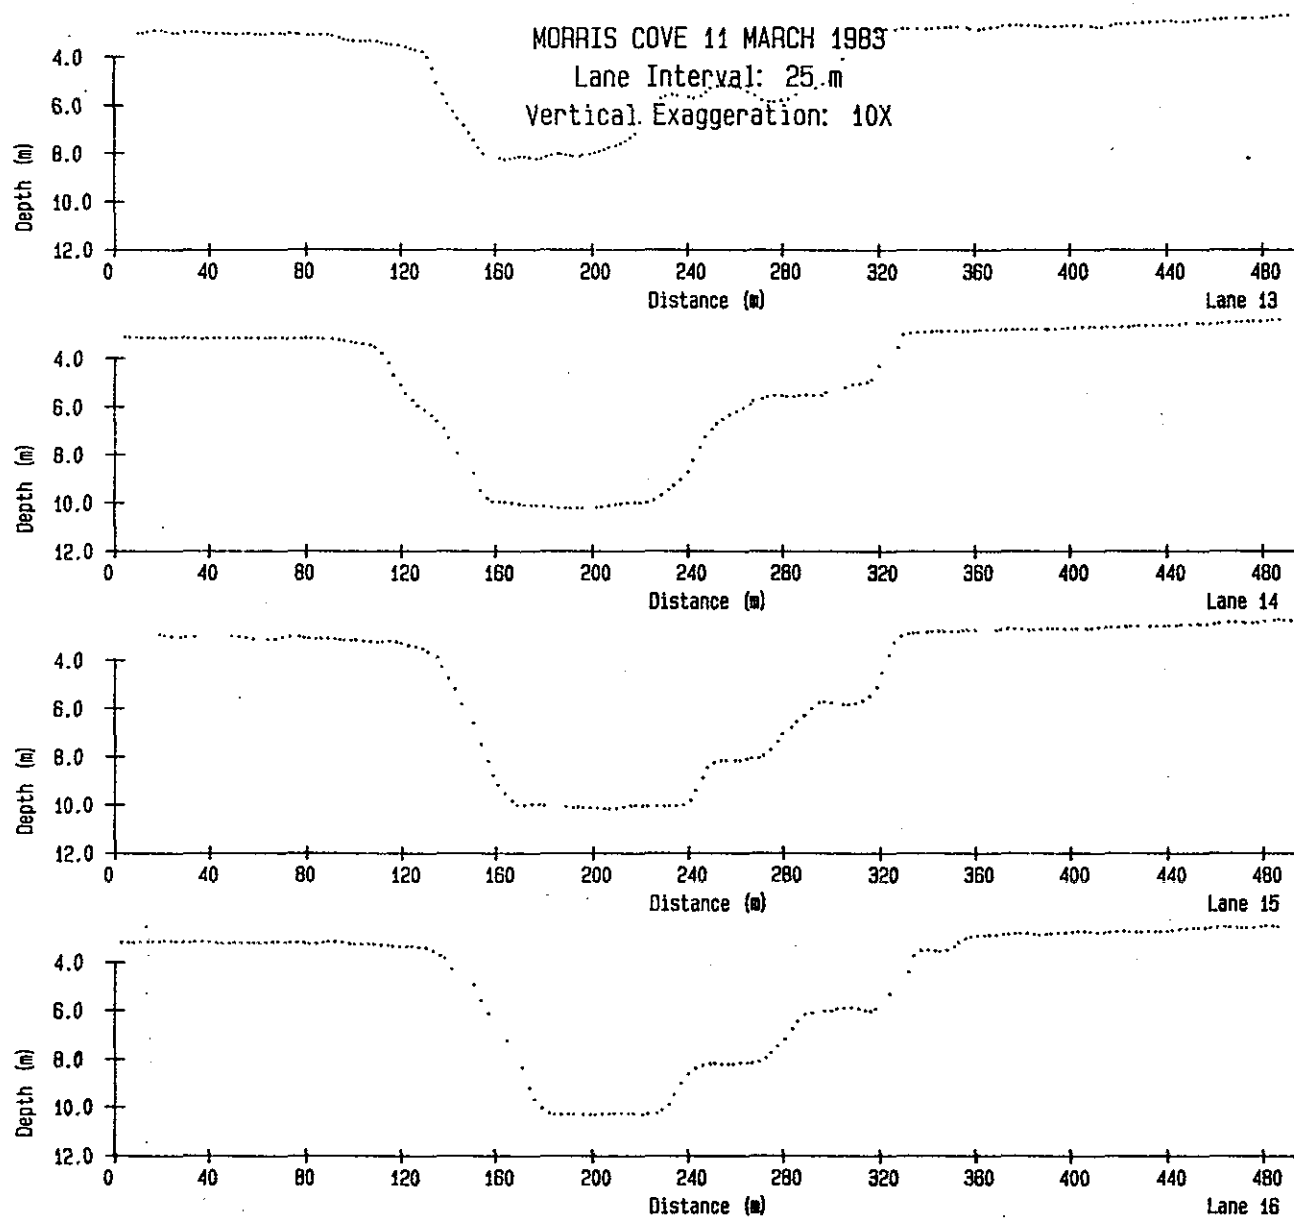
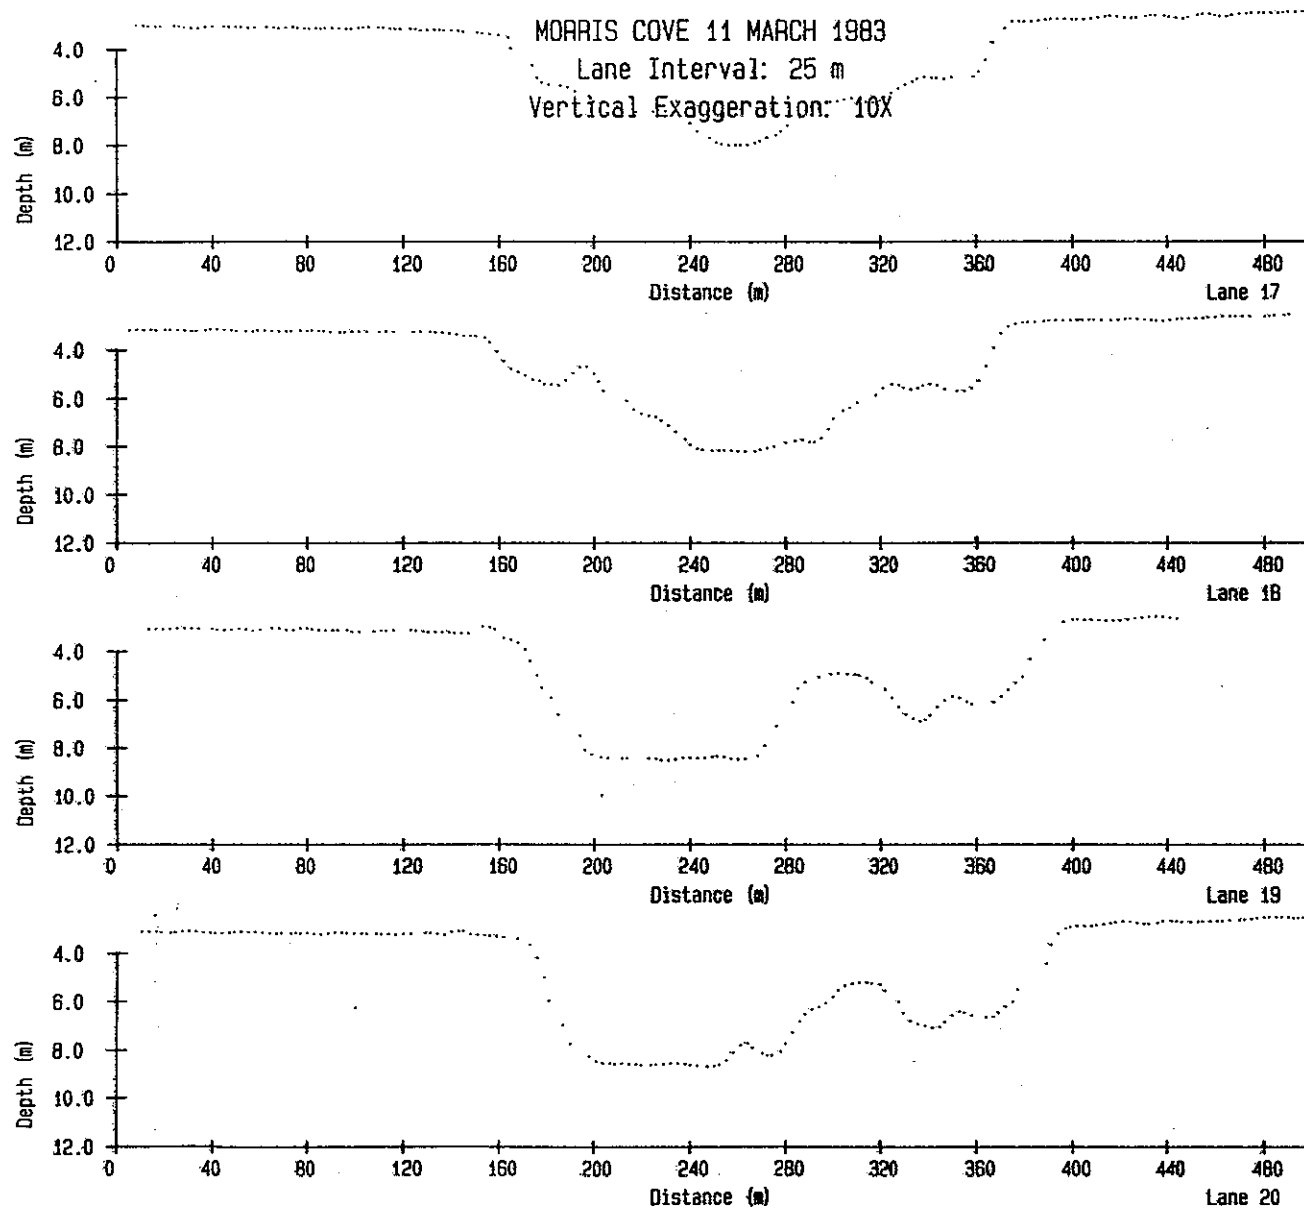
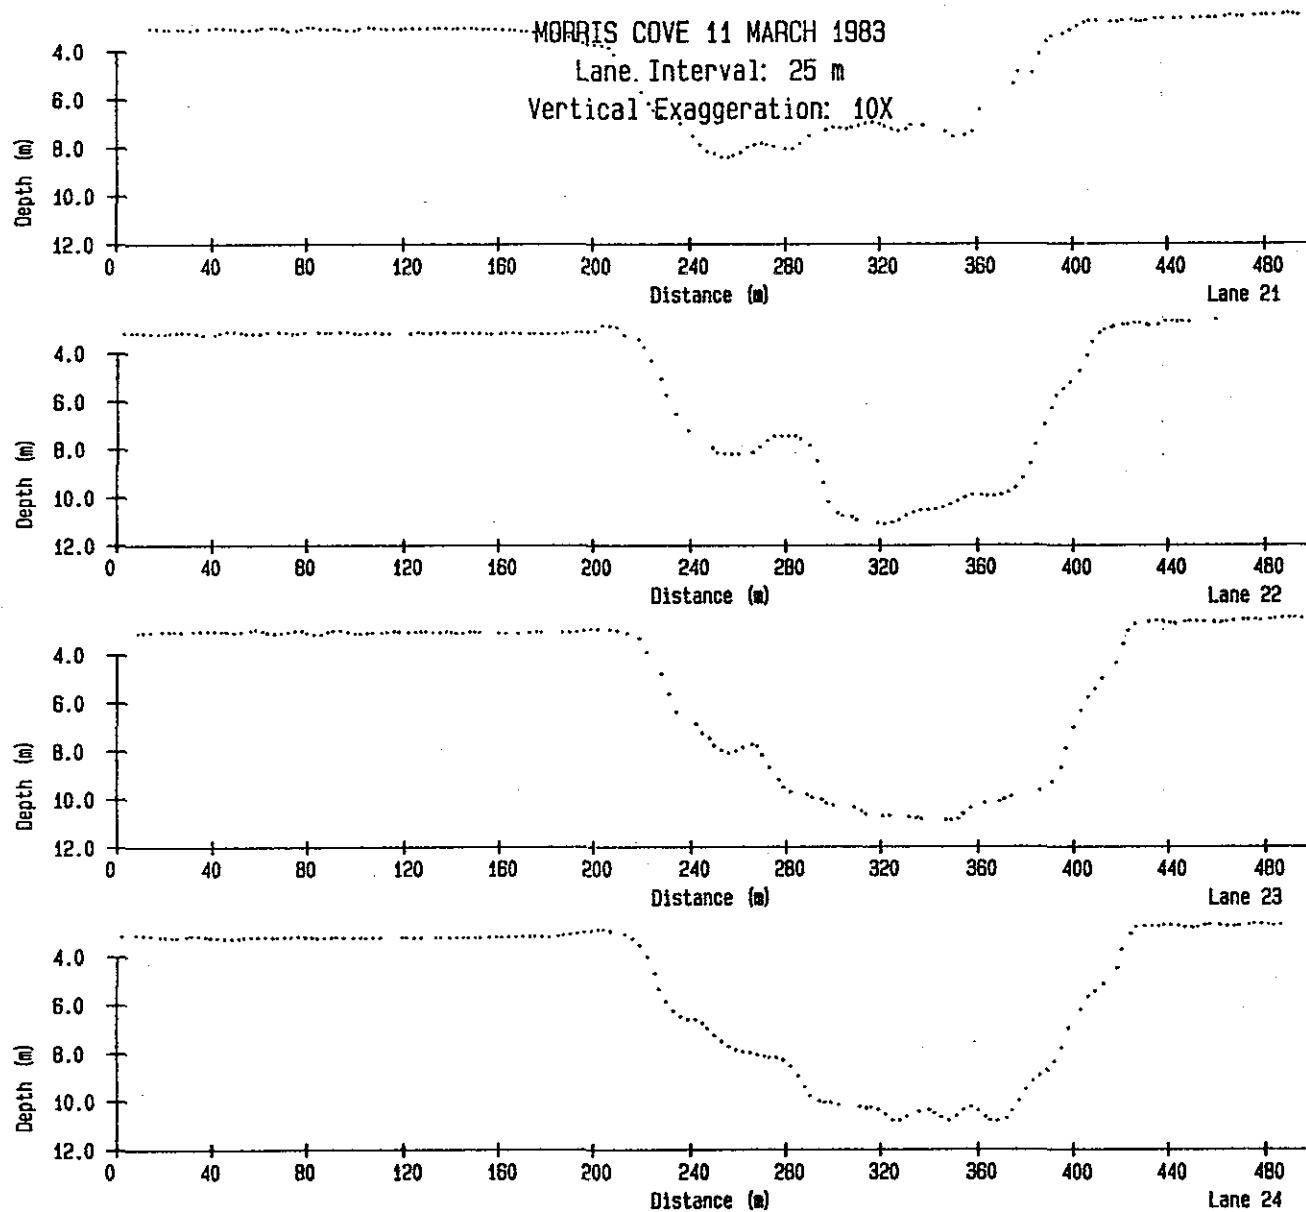
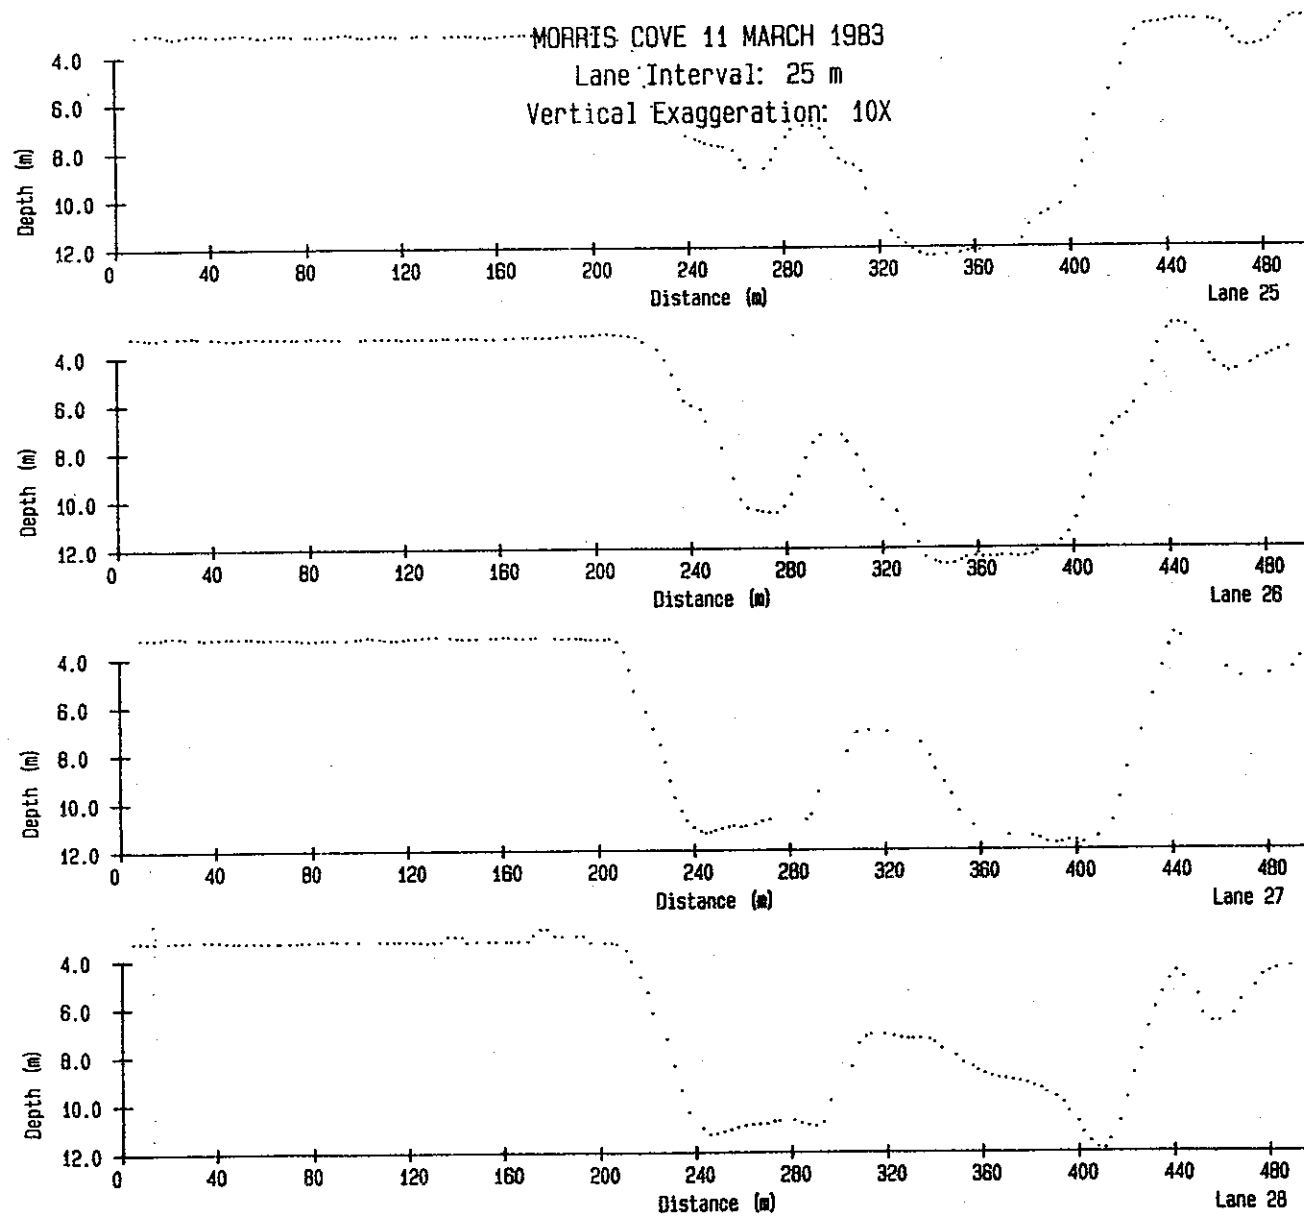
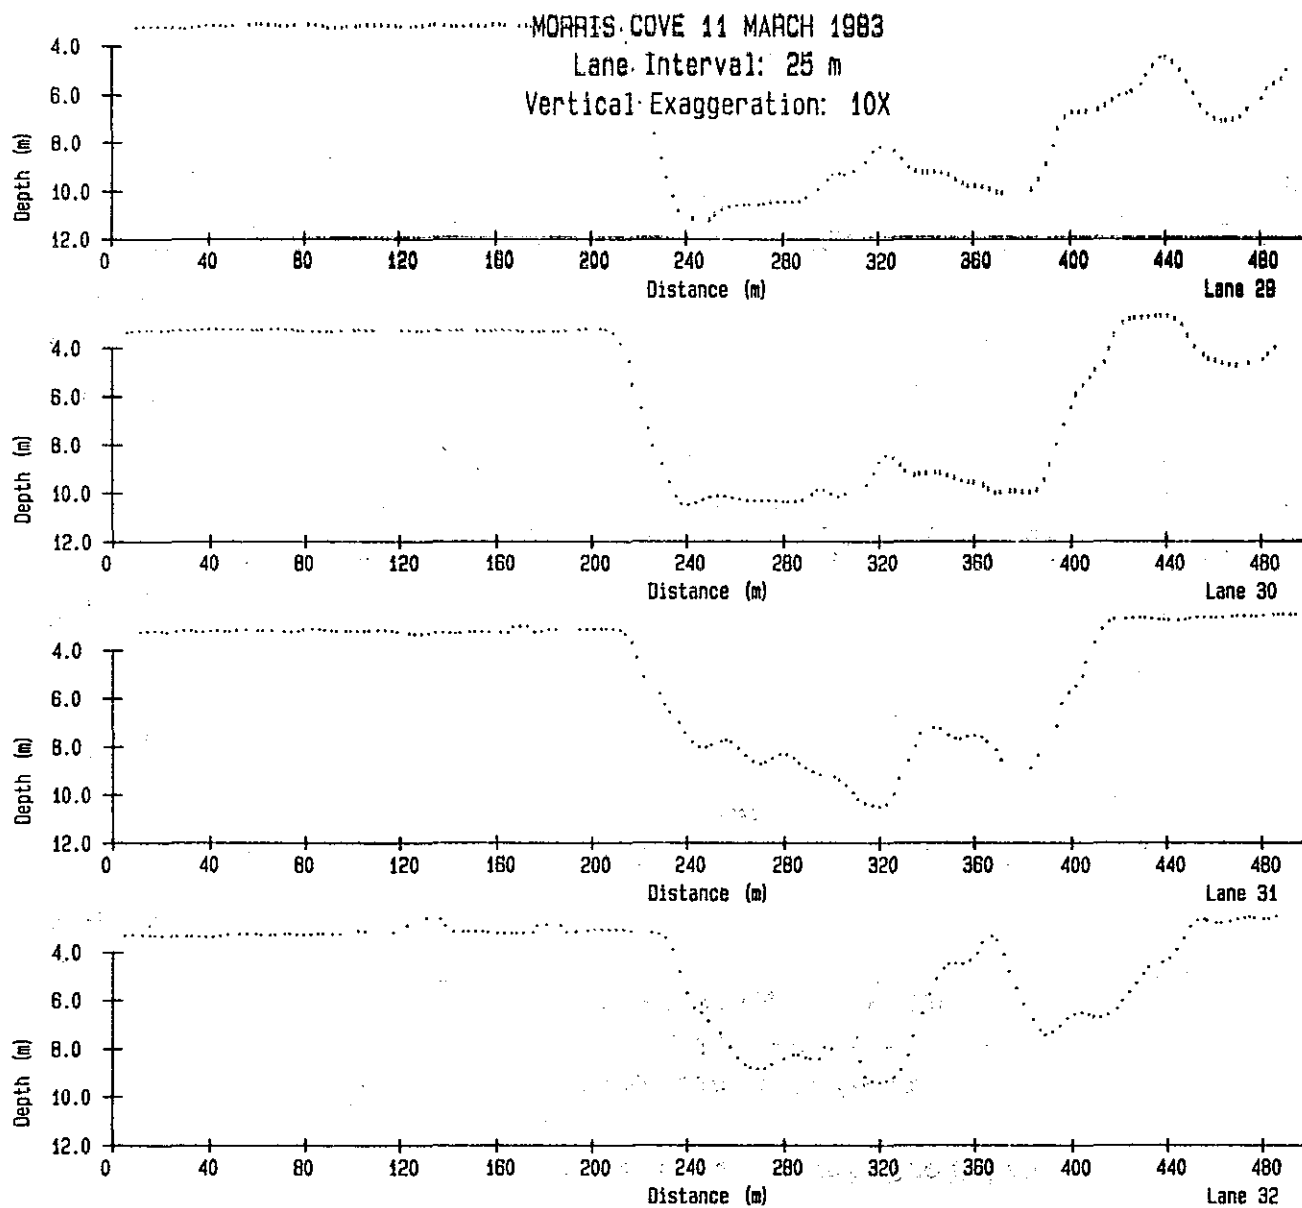
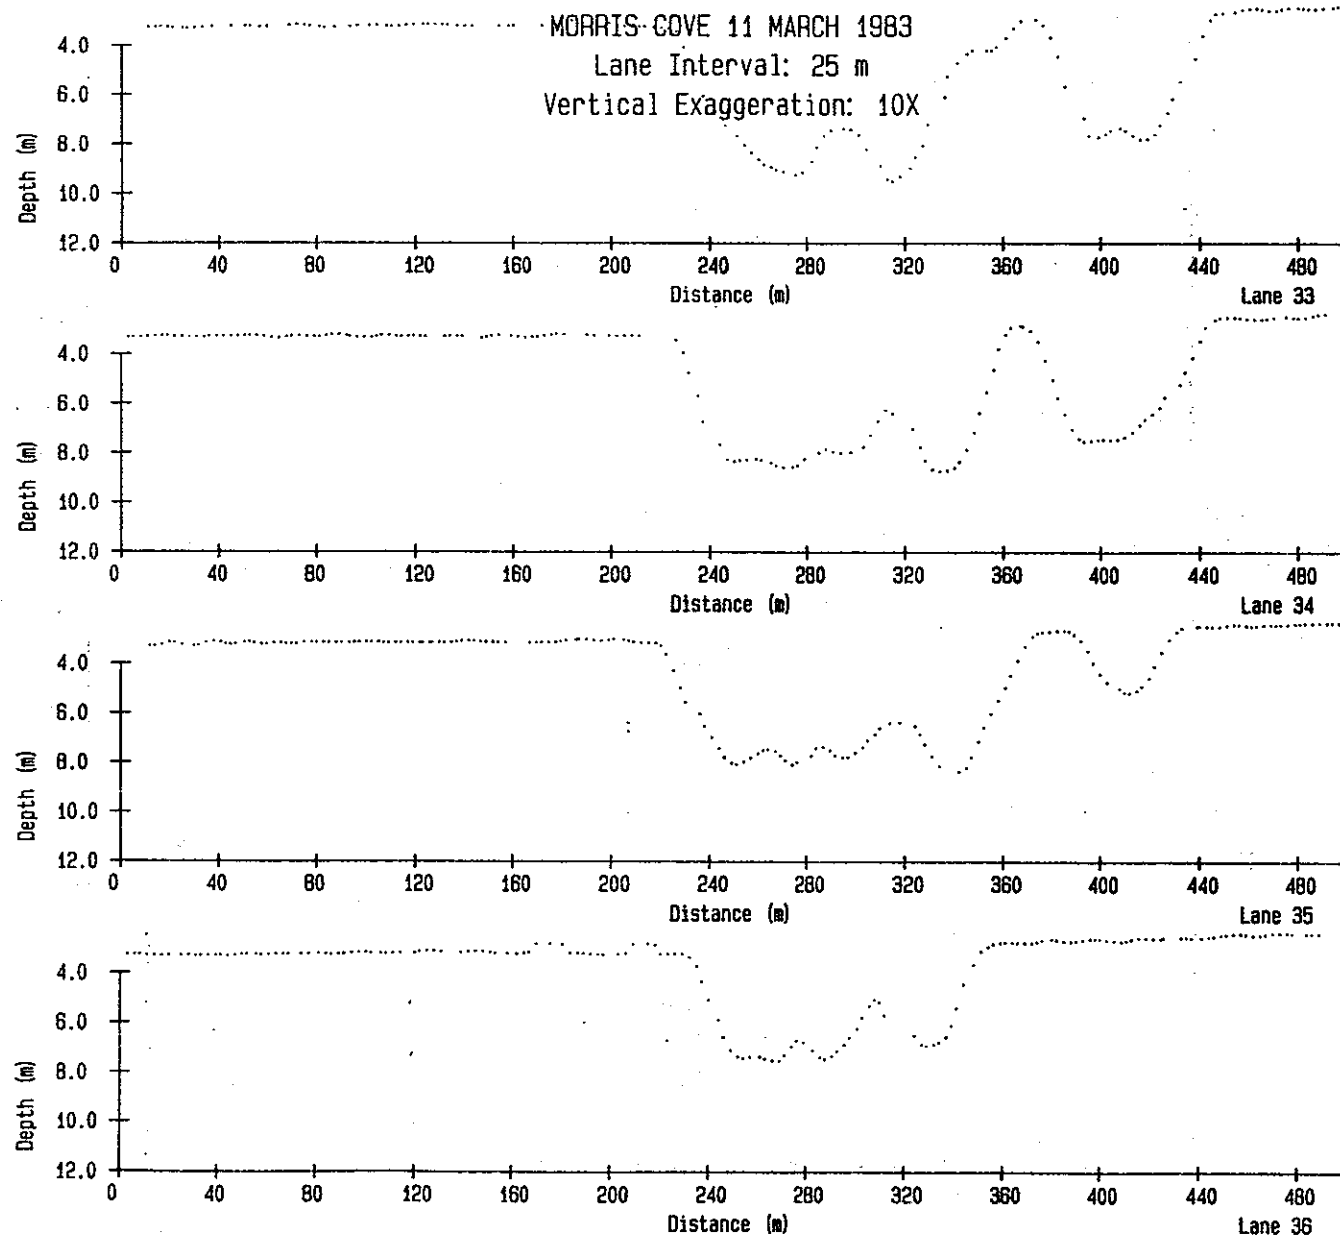
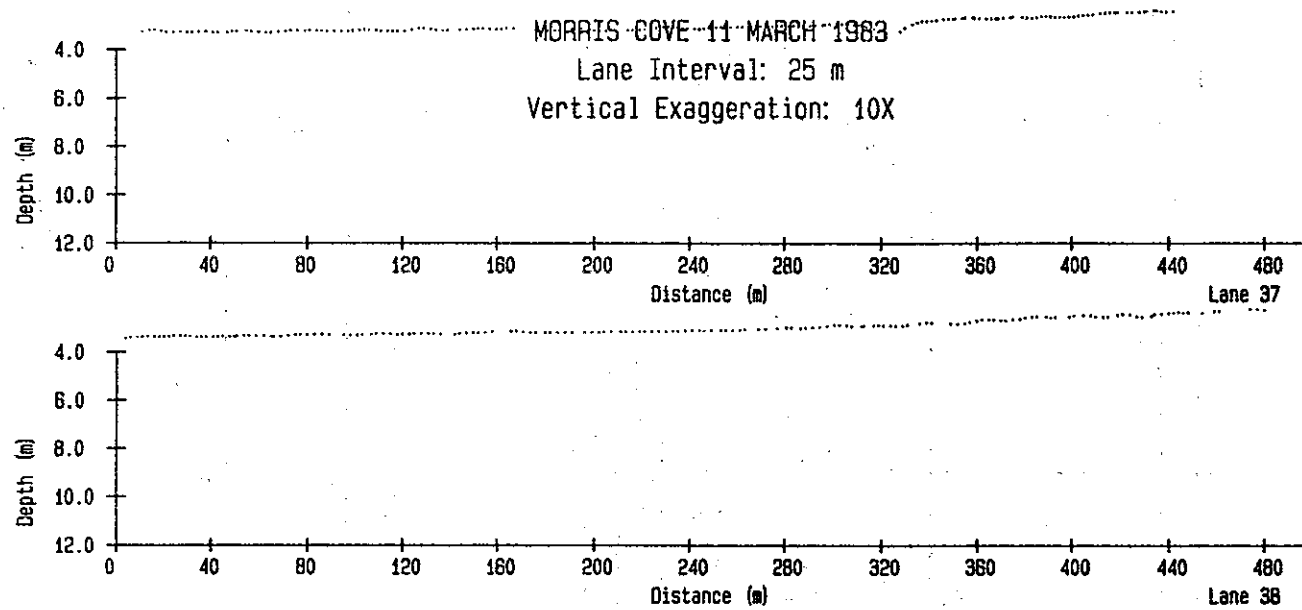
Figures 2.0-2 thru 2.0-11 and contour charts generated from these data are presented as Figures 2.0-12 and 2.0-13. These figures show that the borrow pit is a north-south trending depression which deepens to a maximum depth of approximately 12.5 meters in the south western portion of the feature (lane 26, Fig. 2.0-8). In contrast, the area immediately surrounding the borrow pit may be characterized as flat and featureless with a depth varying from approximately 2.5m at the northern boundaries to about 3.0m at the southern edge of the pit. The width of the borrow pit varies from a minimum of 70m at its northern terminus to a maximum width of approximately 220m across lane 20 (Fig. 2.0-6). Further, while the edges of the borrow pit are generally well defined, there are a few locations notably at the eastern ends of lanes 25 thru 30 (Fig. 2.0-8, 2.0-9) where this boundary is not distinct. The most unusual feature of the borrow pit is the uneven distribution of topography within the pit in the more southern lanes. The profile plots of the northern lanes (lower lane number) show only a single depression in the bottom, while the more southern lanes have profiles which indicate two depressions separated by a rise of as much as 4m (lanes 27 & 28). This topography distribution is most likely the result of material that was not removed during the creation of the borrow pit. Utilizing the volume difference portion of the SAI bathymetric software, it has been determined that 1,207,154 yards³ (922,990 meters³) of material would be required to fill this pit to a level equal to that of the surrounding bottom (Fig. 2.0-14).

Profile plots of the 38 lanes sailed are presented as

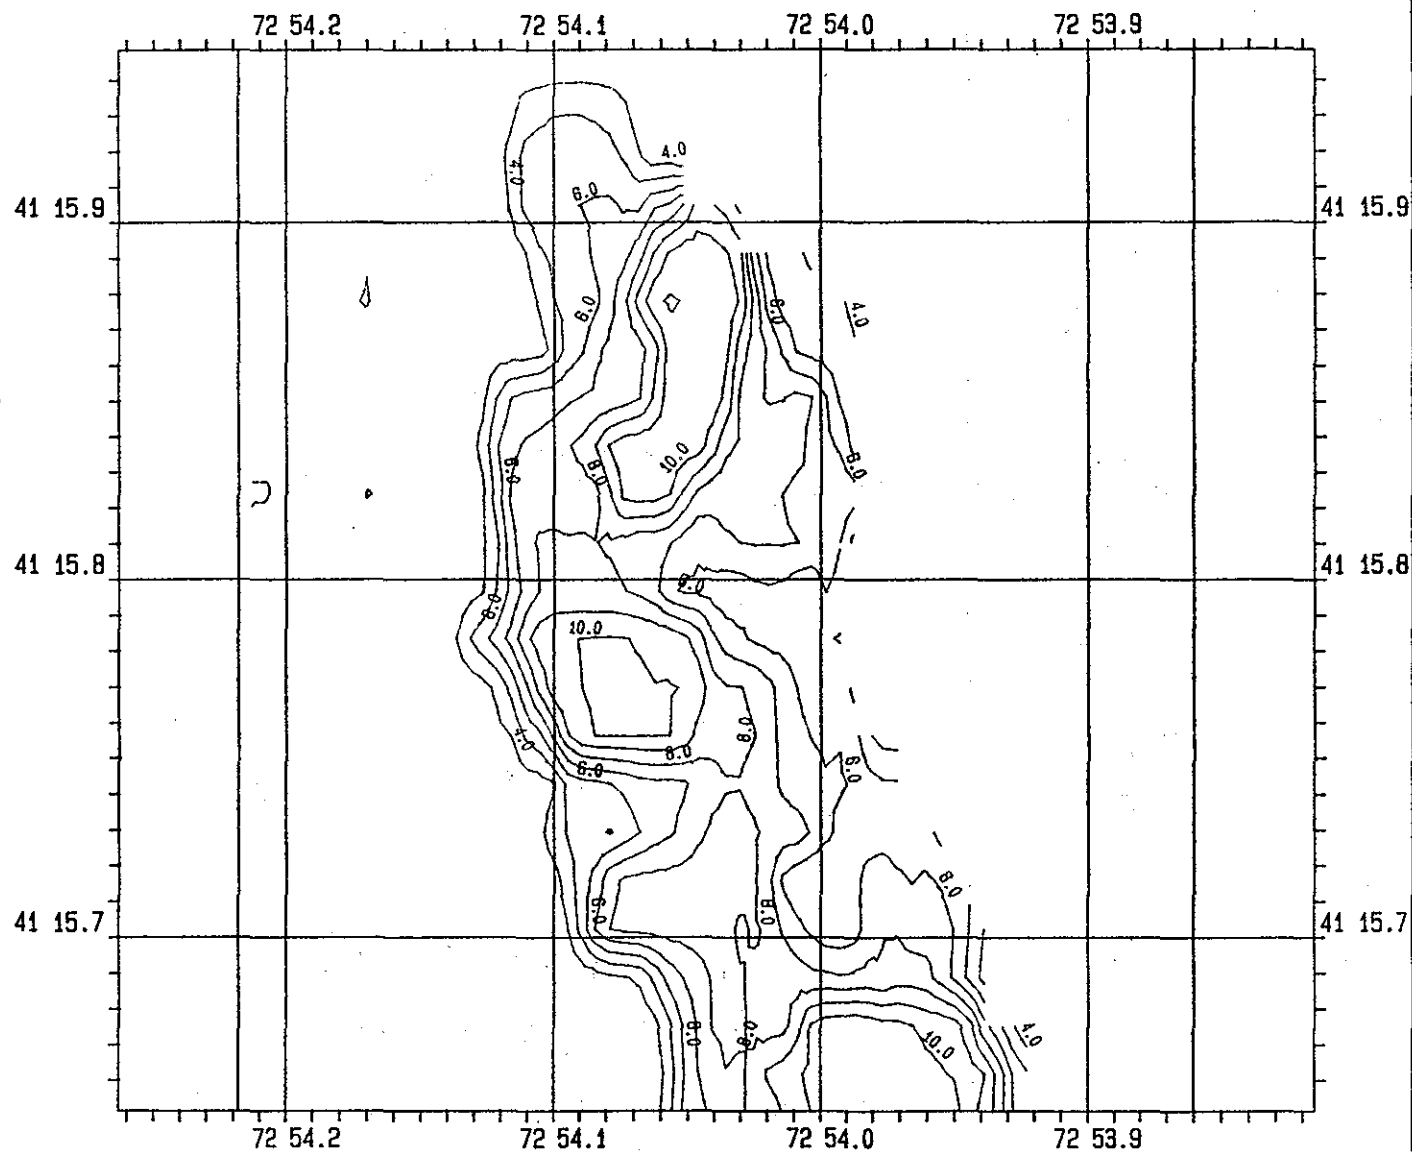
FIGURE 2.0-12

MORRIS COVE
NORTH
DEPTH CONTOURS

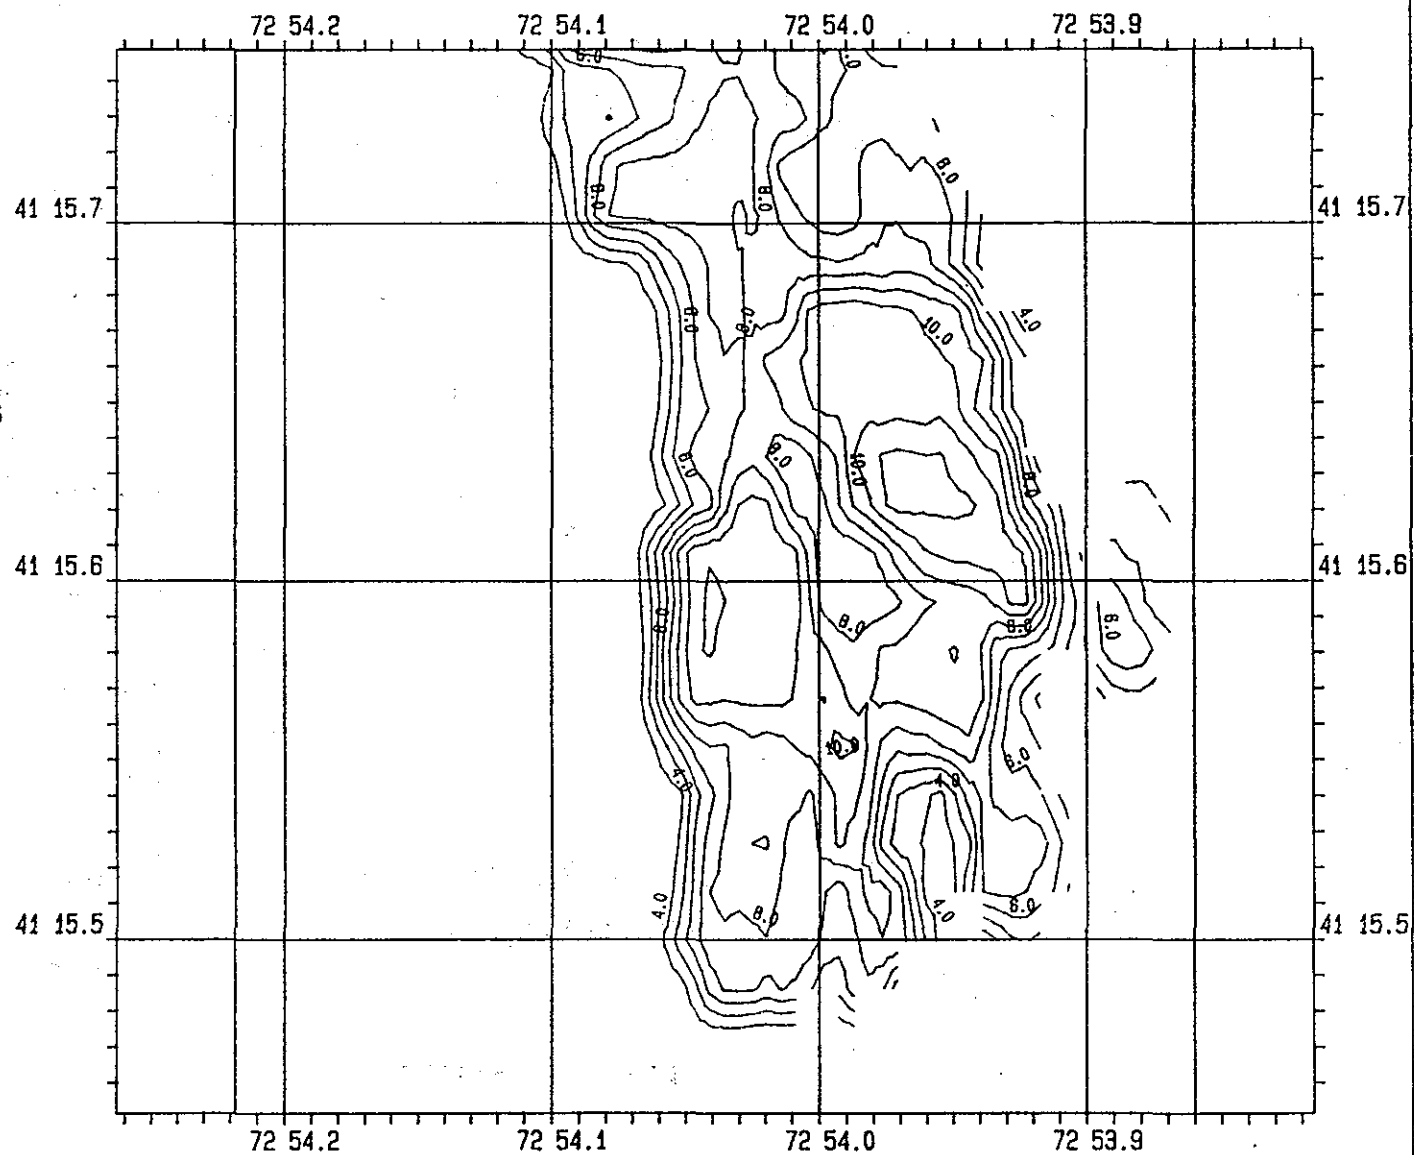
FIGURE 2.0-13

MORRIS COVE
SOUTH
DEPTH CONTOURS
